Qualitative Assessment of River Bank Erosion Risk in Jirania Rural Development Block, Tripura

Dr. Nibedita Das

Moujuri Bhowmik

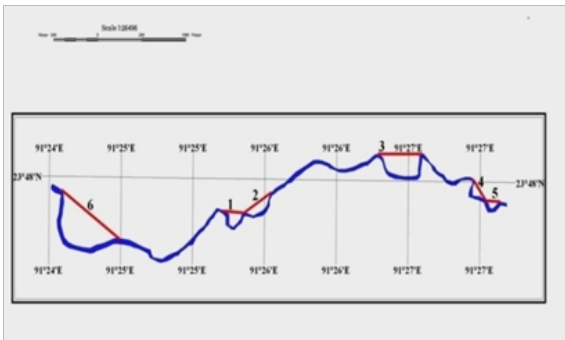
Fig.3: Meander wave length of all sites within the study area.

[Fig.3 about here]160m but at GTP these are 240m and 360m. More is the meander wave length less is the flow velocity attack. Here, among the four sites, second site of RTP is characterized by lowest meander wave length (160m) i.e. meander curvature is narrower, which indicates that at this site the attack of flow velocity is more (0.49m/s). Again, in case of GTP at the second site the River Haora is flowing through a wider meander curvature with 360m wave length and the flow velocity is less (0.36m/s). Due to this process the Hora River bank migrates from north to southward direction within the Jirania Block (Fig. 4).

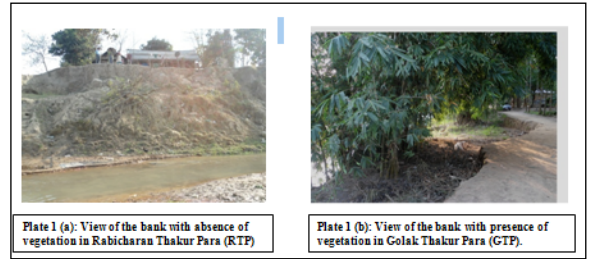
deeply and spread widely, it keeps the soil very tight which resist the attack of flow velocity but where root depth and density is low or absent, as in case of RTP, then high erosion occurs [Plate 1 (a) and (b)]. In GTP root density is 8.63 m/m² due to which less erosion occurs (Table 1).

Due to this hazard many families have lost their houses, livestock, standing crops, significant amount of agricultural lands twice or thrice and had to rebuild their houses which are again under extreme and moderately high risk zones. Therefore, proper protection measures are necessary to save these erosion risk prone areas through revetments, plantation of trees etc. thereby increasing the stability of the banks.

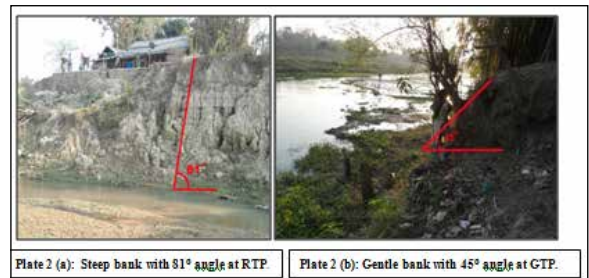
- Bank angle: Gentle bank angle is less susceptible to bank failure in comparison to the steep slopes. The River Haora has a steep bank (81°) at RTP [Plate 2 (a)] whereas in GTP the bank angle is moderate (45°) [Plate 2 (b)]. Steep banks with non cohesive materials favour the process of liquefaction which leads to the collapse of the overhanging portion of the bank after high water level drops.

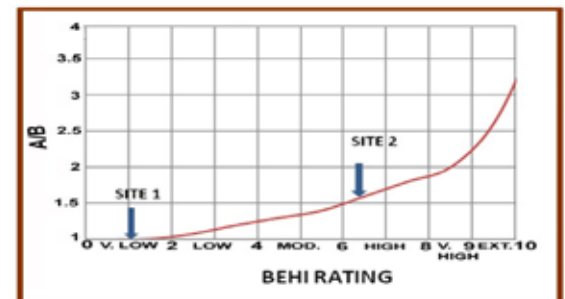
Fig. 5(a): Bank Height Ratio of the banks at Golak Thakur Para (1) and Rabicharan Thakur Para (2).

Site	A / B	BEHI Rating
Golak Thakur Para (1)	1.0	Very Low (1.0)
Rabicharan Thakur Para (2)	1.67	High (6.4)

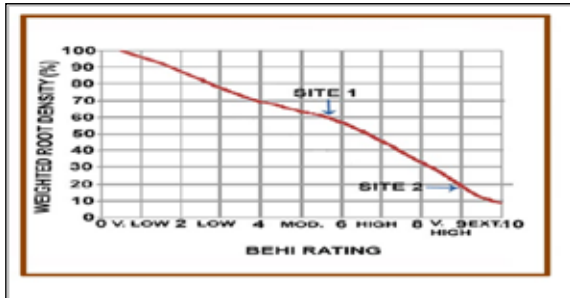
Fig. 5(b): Weighted Root Density of the banks of Rabicharan Thakur Para and Golak Thakur Para

Site	F * E	BEHI Rating
Golak Thakur Para (1)	60%	Low (5.7)
Rabicharan Thakur Para (2)	17 %	Very High (9)

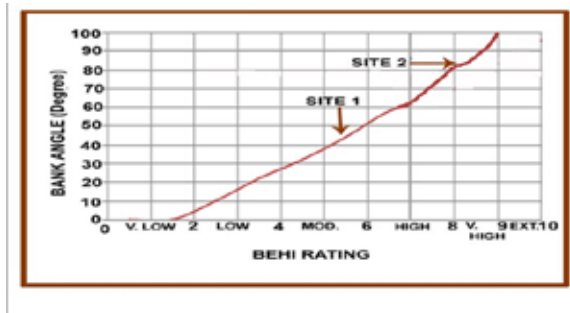
Fig. 5(c): Angle of the banks of the River Haora at Rabicharan Thakur Para and Golak Thakur Para

Site	(H)	BEHI Rating
Golak Thakur Para (1)	45°	Mod (5.6)
Rabicharan Thakur Para (2)	81°	High (8.3)
