The Evaluation of The State of Instability of The Historic Monument Construction Villa «Mihail Sutu » - K. Zambaccian Street No.1, Constanta, Located In The Active Area of The Lack Sea's Waterfront

Simion Gemanaru Ancuta

Gramescu Ana Maria

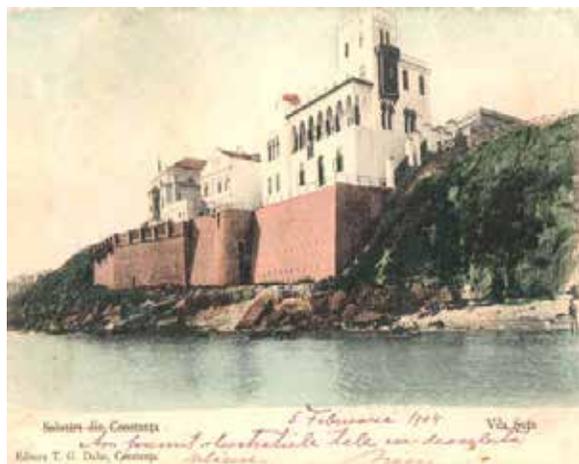
Figure1 - Photo from the years 1902 – 1903 [2]

In the foreground is visible rock that was founded retaining wall and drainage system for its water intake from the base layer of loess.

In the south of the villa Sutu older building and the retaining wall of the adjacent cliff which was destroyed in the early interwar period due to the instability of the cliff.

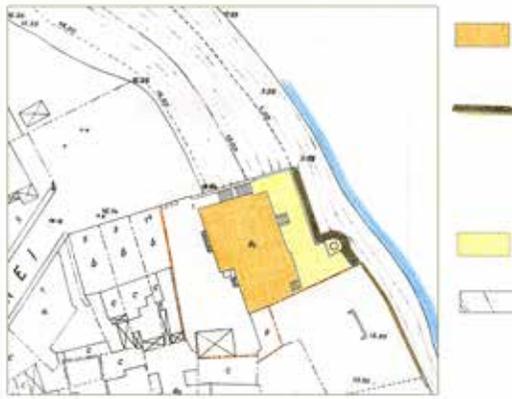
Figure 2 [3] [4]

- Building of the Villa (basement, ground floor)
- Wall to stabilize the cliff, changed from the initial design for connection to existing wall in the south
- Paved platform stuffing
- Built-up areas in the years 1880 - 1890, directly affected by cliff instability

The land where the building was realized is located on the edge of the cliff, whose natural slope was 40°- 45° and was under constant phenomena of collapse, because of the specific geotechnical structure, and the direct action of the sea waves during strong storms from north and north-east (figure 2).

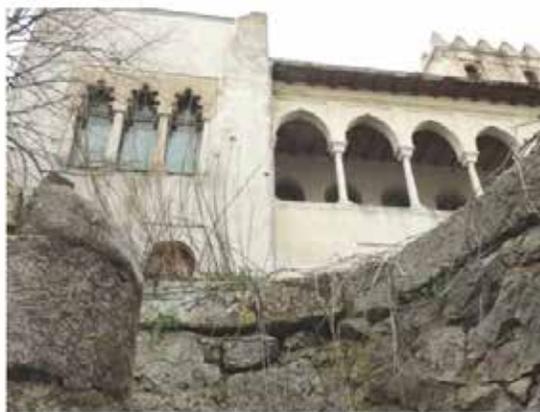
Figure 3
Photo from the years 2015. Photo source Artmark Historical Estate [5]

In these conditions, for the stability of the construction of the villa were necessary distinct workouts for protecting and stabilizing the cliff, was built a retaining wall with a slight slope towards to inside, and equipped with inside buttresses and horizontal drains to discharge groundwater and infiltration. This wall was made of half shaped stone on outside, built with cement, with a thickness of 1.00 m at the base, founded directly on the Sarmatian limestone cliff, after being removed from its surface damaged layer (upper layer share of the limestone in this area is approx. 2.5 to 3.0 m above sea level). (figure 3) [9]

Compared to the initial project, in the conformity with the authorized documentation, the route of protective wall was modified, amended to the need of connection to a similar construction, to protect older homes located in the south of the designed buildings. [2]
