## Hot Corrosion Phenomenon In Super Heater Tubes & Its Impact on Life of Super Heater in Thermal Power Plants

##### Case-I: Failure of high temperature Super heater tube no.7 of assy no 3 of unit #4 (Boiler KSTPS Plant)

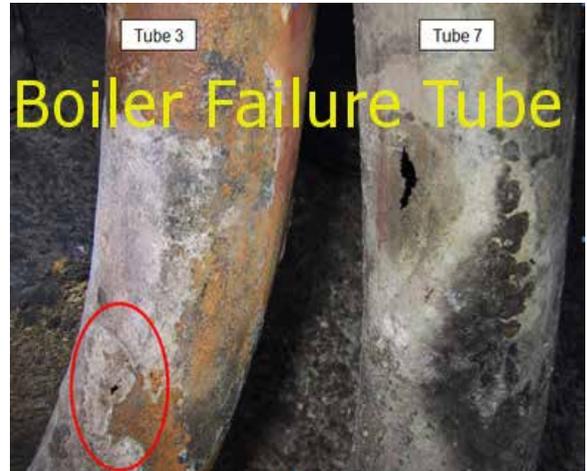
Figure2-Failure in super heater Tube No.7 & 3

During service, the material or tube is subjected to higher temperature than the oxidation limit of material, bulging burst opening with thick lips, flown off the fractured portion, oxide scale on ID and OD surface of the tube are observed in the failed end of the tube

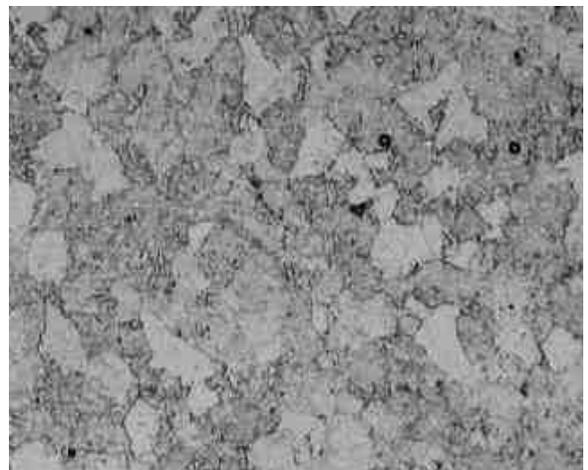
Figure4 Micrograph shows microstructure of parent metal. Location tube no.7 of SH(X200)

Microstructure shows ferrite grains along with bainite/pearlite. Micro/macro cracks are observed in parent metal; cracks appear to have formed in oxide/slag inclusions. Fine bainitic structure is observed in cracks region. Spheriodization of pearlite is observed. Cracks are parallel to circumferential weld.

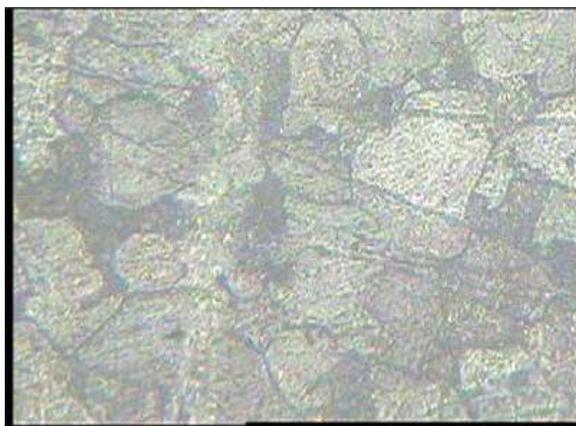
Figure5- Degradation in microstructure

IN-SITU Metallographic indicate the cause of failure of super heater tube is degradation in microstructure level

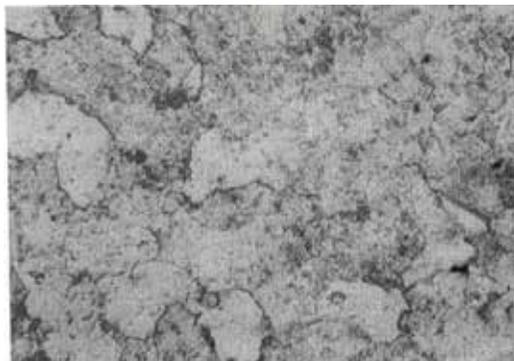
#### Figure6 Microstructure of SH Tube No:7

Presence of intergranular and transgranular multi-branch cracks and occurrence of thick walled fracture indicates failure caused by stress corrosion cracking (SCC). It is suspected that earlier during replacement this particular portion of the super heater tube could have been used without identifying the material because failure is due to use of incorrect material.

Microstructure reveals uniformly distributed pearlite & ferrite. Pearlite completely spheriodised but carbide still included in primary pearlite grains.

The chemical composition of the tube no. 7 does not meet the requirement of standards but corresponds to typical carbon steel. In failed side of the tube graphitisation is very much found, presence of S in the fuel oil ash deposits on the fire side surfaces of the tubes appears to be the main cause of failure because this molten deposition is damaged the protective surface oxide. Failure of the tubes is most likely due to hot corrosion. Presence of sulphur had accelerated the corrosion leading to perforation of the tubes. Use of Cr - containing steel SA 213-T22 will recommend minimizing corrosion.
