SILTING PROBLEMS IN HYDROPOWER PLANTS

Sourabh Khurana

V. CASE STUDIES

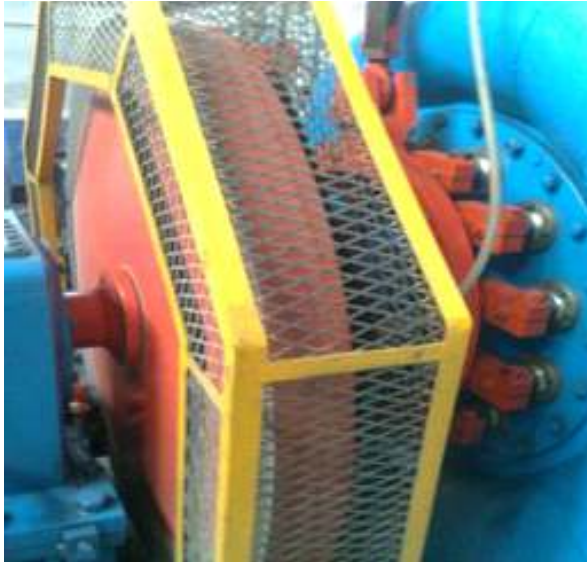
Figure 1: Francis Turbine

- Penstock Diameter 3m
- Rated Discharge 1.015 cubic meter per sec.
- Due to silt erosion in blade occurs.

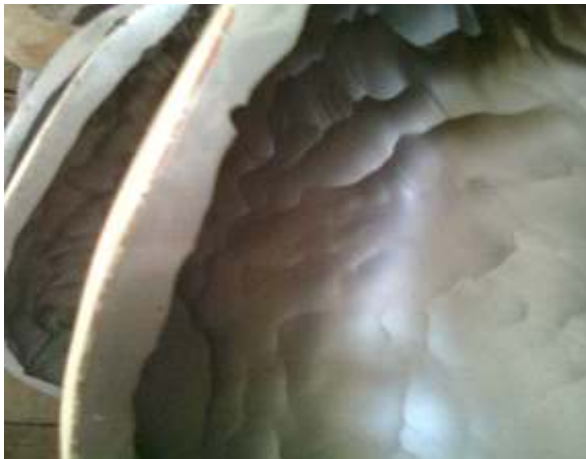
Figure 2: Eroded Blade

- Capacity (2 × 1.5MW)
- Set up year 2005
- Pelton turbine
- Efficiency 83%
- Net Head 297m
- Due to presence of silt runner has been replaced after 2 years
- Eroded blade is shown in Figure 2

In this hydro project during monsoon season concentration of silt particles was around 3000 ppm. Due to presence of quartz which is having hardness 7 on Moh's scale. Due to quartz runner was replaced after two years of operation. We can observed that how material removes after striking of silt water to buckets of turbine.

Based on investigation it was observed that material removal was due to plastic deformation and ploughing of surface.

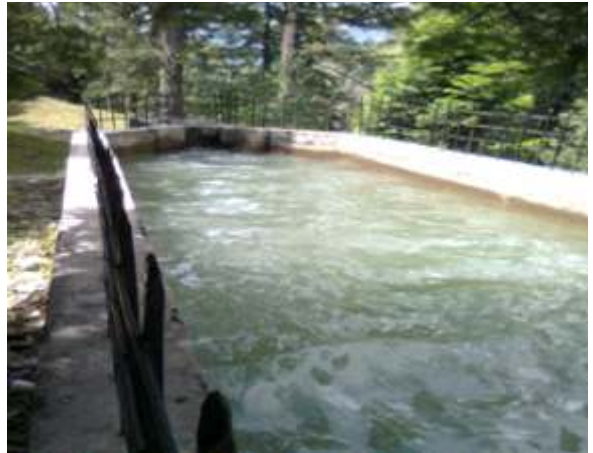
Figure 3: Desilting Chamber

- Capacity (2 × 2.5MW)
- Set up year 2007
- Pelton wheel Turbine
- Efficiency 85%
- Net Head 350 m
- Due to presence of silt Buckets and runner effected and coating is used (Stellite)
- Desilting chamber used to remove silt
