## Investigations on Stone Weathering of Ottoman Architecture: A Kirklareli Hizirbey Kulliye Case Study

\* Murat Dal \*\* Ali D. Öcal

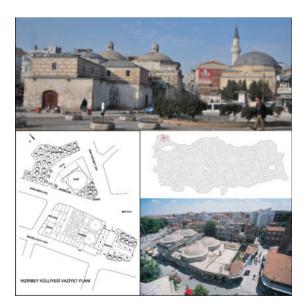
Figure 1. Exterior of the Hizirbey Kulliye viewed from the East and the environmental situation of the kulliye and surround area.
