# Electronic Systems Damaged by Corrosion in The Electronics Industry of Mexicali

**Gustavo López Badilla**

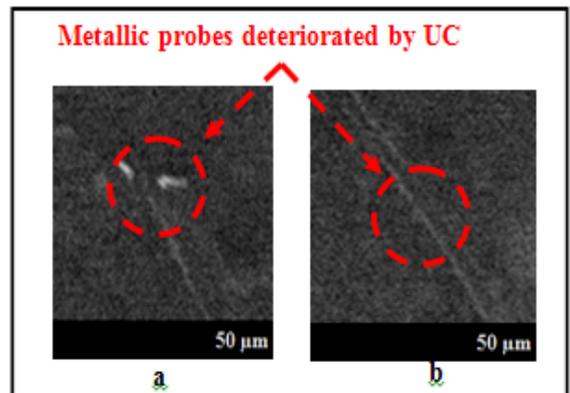
**Figure 1 Metallic specimens of (a) silver and (b) copper, damaged by the corrosion process occurring uniform corrosion (February 2014-winter period).**

Metallic probes evaluated at 1, 3 and 6 months showed the grade of deterioration by the atmospheric corrosion in indoors of the industrial plant where was made the study. In the microphotographies, are observed two zones detected. In figure 1 the white areas, are the metallic surfaces without corrosion products. This mean that the metal was damaged and some pieces of metals emerge, reducing its surface area. This is not good for metallic surface of electrical connections to ED, because it not permits the electrical conductivity and ED reduce their operation yielding. In figure 1, the majority of the metallic surface is covered by the corrosion products as a uniform corrosion and occurred in six months of the study with high RH and low temperature levels. In figure 2, are observed with major intensity two zones as white and black areas of the metals evaluated. This occurred in one month, in the summer period, where levels of RH and temperature were higher. This is not good to the ED, as is mentioned in the explication of figure 1.

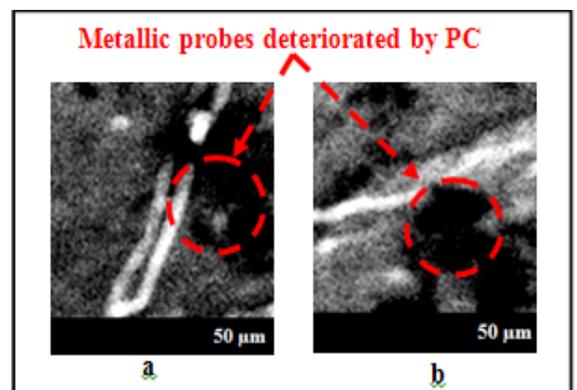
**Figure 2 Metallic specimens of (a) silver and (b) copper, damaged by the corrosion process occurring pitting corrosion (August 2013-summer period).**
