Title of Paper-Case Study on Corrosion Phenomenon in Water Wall Tubes of Boiler in Thermal Power Plants

Case Study: - Front Water Wall Tube No: 5&6 of unit #1

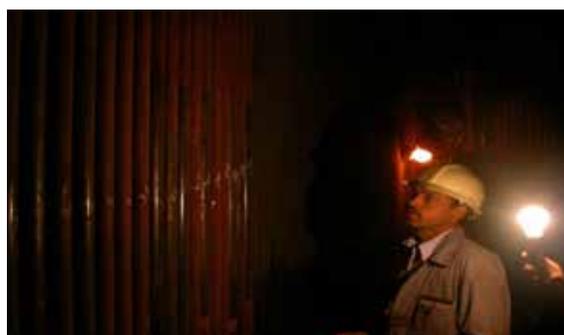
Figure1:-Visualization of water wall failure tubes

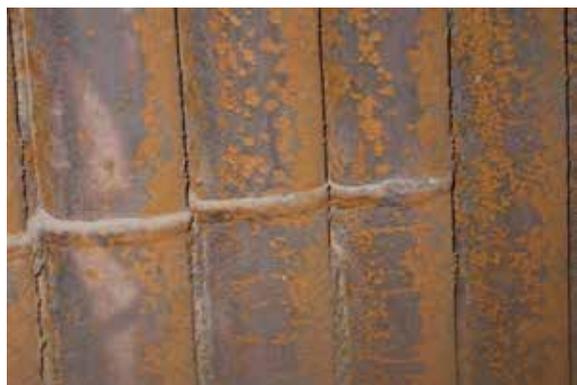
Figure 2 – corrosion observed in water wall tube

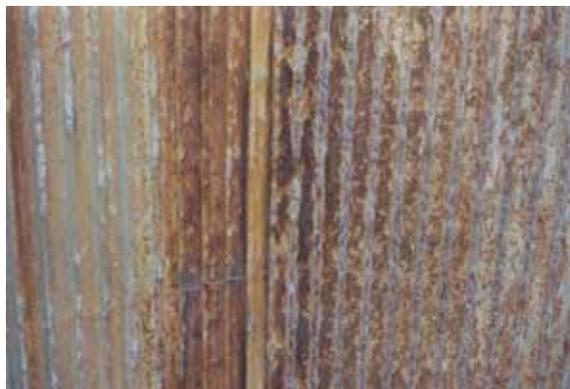
A case study is made on tubes no 5 & 6 of water wall at unit no.1 of kota super thermal power station and details of various test conducted on these water wall tubes are collected to perform a case study. The test results are compared against established limits and conclusions are drawn. The results of chemical analysis conducted are shown in tabular format. During In -Situ metallographic replicas were taken which shows the micro-structural degradation due to corrosion attack on sample tubes.

Figure3- Corrosion observed on water wall tube

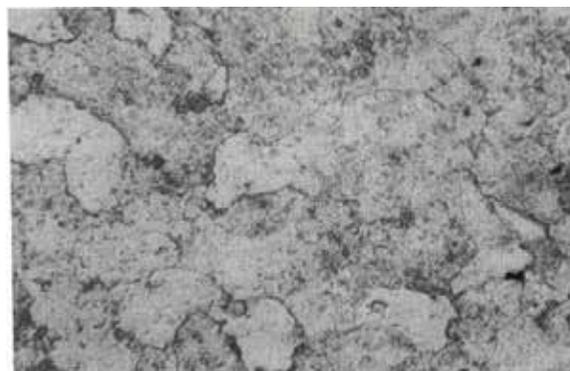
The tube was transverse sectioned and micro examined at the failed region. It showed severe external wastage and wall thinning from OD surface towards ID surface. Oxidation of the edges are observed at the failed region. The microstructure of the tube at the failed shows polygonal grains of ferrite & pearlite. Opposite to the failed region and on a ring section a little away from the failed region, similar microstructure is observed. Microstructure shows ferrite grains along with bainite/pearlite. Spheriodization of pearlite is observed. At few places fine bainitic structure is observed. Spheriodization of pearlite is observed. Microstructure shows fine dendrites of ferrite with bainite at weld.

Figure 4:-Microstructure of front water wall tube no: 5

The failure of the tube no 5 is attributed to external metal wastage and subsequent wall thinning. Hence immediate chemical cleaning is required. since the water wall deposit quantity is comparatively high, it is recommended to carry out deposit density measurement of tubes during next available outage ,the presence of copper (1.7%) in the deposit indicates pre boiler corrosion and subsequent deposition on water wall tubes ,water chemistry guidelines have to be measured and monitored properly to minimize the pre boiler corrosion ,Visual examination of water wall tubes no 6 revealed deposits on tube surfaces, normal pitting also noticed. Corrosion observed on tubes in furnace and hopper zone area. No misalignment found visually. Visual inspection of water wall tubes revealed surface deposition and normal scaling. Misalignment observed on tube surface. Distortion /deformation were also noticed. From analysis of observations taken for corrosion of water wall tubes, it could be concluded that corrosion is the major cause of failure. Various N.D.T. (Non-Destructive Techniques) are useful to determine the performance of water wall tubes & therefore reduce outages. Visual inspection of this intermediate tube surfaces revealed scaling and corrosion at bend areas. Misalignment was also observed in some of the tube coils. No any other physical damage or discontinuity observed, selective tubes are being replaced, Examination showed heavy oxide scale and corrosion on the surface of tubes. No other abnormality found visually, for analysis of corrosion failure in water wall tubes, various data's were obtained and analysis tables were prepared for this tube by conducting various tests. Methods of corrosion failure control depend on type of corrosion encountered. The most common cause of corrosion are dissolved solids and under deposit attack& low pH, and these factors can be controlled by maintenance of proper pH and alkalinity levels, control of oxygen and boiler feed water contamination, reduction of mechanical stresses, operation within design specifications, especially for temperature and pressure, proper precautions during start-up and shutdown, effective monitoring and control, Effective corrosion control monitoring is essential to ensure boiler reliability. Lastly we can say that by knowing the various aspects of water wall tubes failure, efficiency of power plant can be increased by reducing outage due to corrosion in water wall tube and ultimately reducing the cost of electricity.
