## Strengthening of structures using with Glass Fiber Reinforced Polymer Sheet

Deepa A Sinha

### ABSTRACT

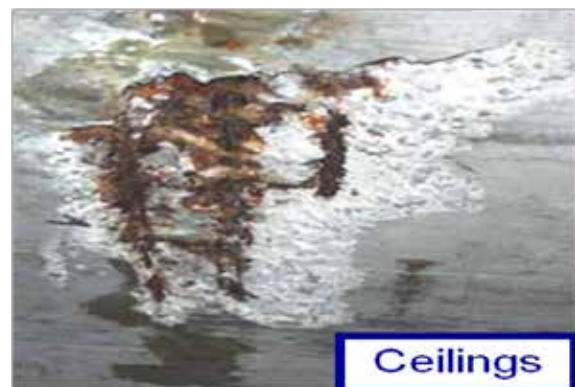
Fig. 1 Typical Corrosion Area

matrix react with penetrating CO<sub>2</sub> to form carbonates. Carbonation is not generally harmful for concrete itself, but these reactions are accompanied by a drop of the pH of the concrete pore water. Carbonation and chloride penetration are the initiating factors for corrosion of steel reinforcement in R.C.C.

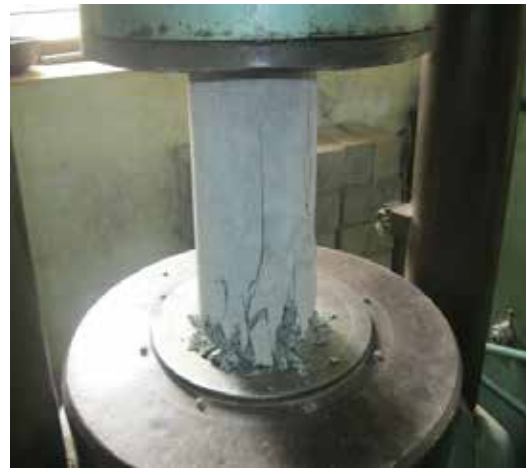
Fig 2 Compression strength of the specimen before repair

Table 1 Cylinder compressive load before repair

Tonne
1	58
2	61
3	63
Average	60.66

It is observed that the compressiveload obtained for the sample concrete is found to be 60 tons for average of 3 cylinders.

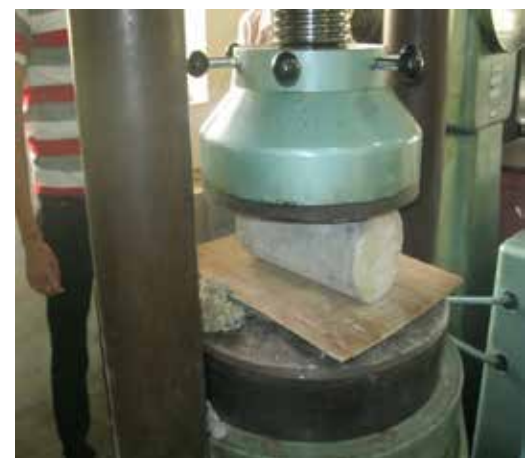
Fig 3 Tensile strength of the specimen before repair

Table 2 Tensile strength of the specimen before repair

Sr No	Tonne
1	23
2	28
3	27
Average	26

It is observed that the tensile load obtained for the sample concrete is found to be 26 tons for average of 3 cylinders. Now a cylinder with minor cracks obtained by applying almost 50% of the crushing load is wrapped by the GRPF and then the tensile load is found to be 28 tons, almost 7.7% increase in strength.

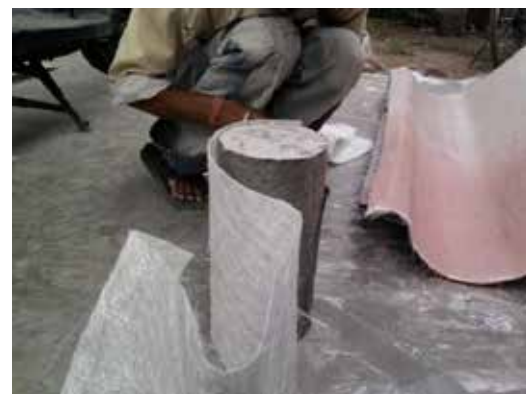
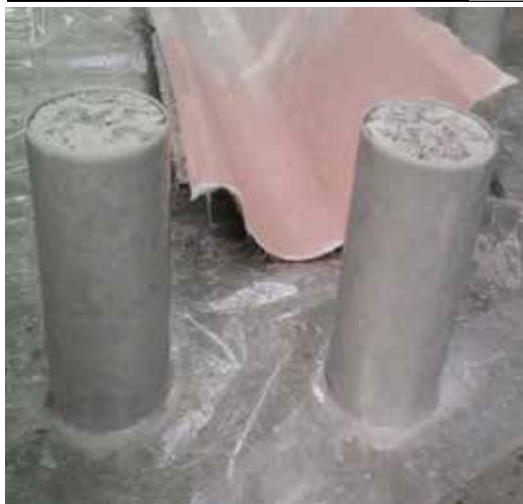
Fig 4 Specimen is repaired with glass fiber Reinforced polymer sheet by wrapping

Average crushing load of specimen are to be found out by testing under compressive & tensile load Then by applying 50% of the crushing load is applied to develop the crack in the specimen. Then specimen is repaired with glass fiber Reinforced polymer sheet by wrapping it as shown in the figure 3

- G.F.R.P has very high tensile strength. About 1020 to 4080 N/mm<sup>2</sup>
- G.F.R.P are made up of 2000 to 4000 individual filaments which are lightly bonded to make up a strand .
- We have used 2mm thick G.F.R.P sheet having grade 450 , grade resin, catalyst 3 percent & MEKP accelerator

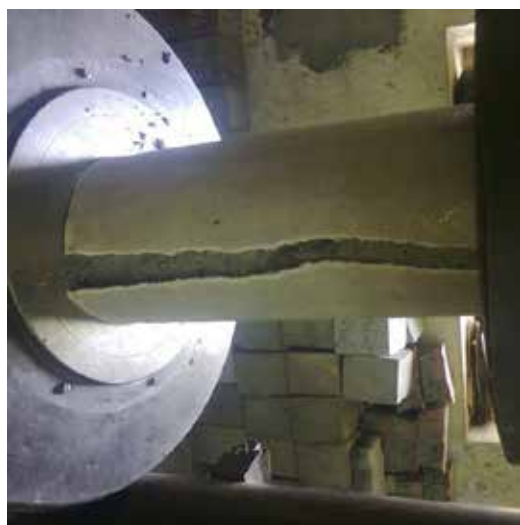
Fig5 Compressive Strength after G.F.R.P. Application

**Table 3 Compressive Strength after G.F.R.P. Application**

Tonnes
1	97
2	99
3	99.5
Avg.	98.5

By applying almost 50% of the crushing load minor cracks were observed . These specimen when wrapped by the GRPF , the compressive load was found to be 98 tons, almost 62% there was increase in strength.

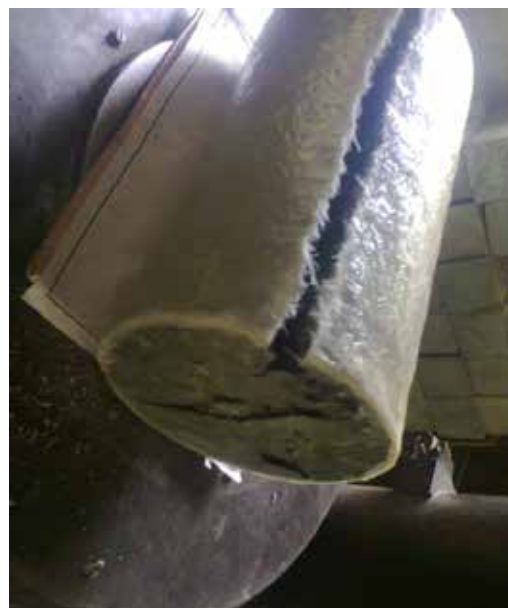
Fig6 Tensile Strength After G.F.R.P. Application

**Table 4 Tensile strength of the specimen after repair by wrapping with GRPF sheet**

TONNES
1	28.67
2	27.3
3	27.7
Avg.	27.89
