Implant failure in total hip replacement –a case report

Case report

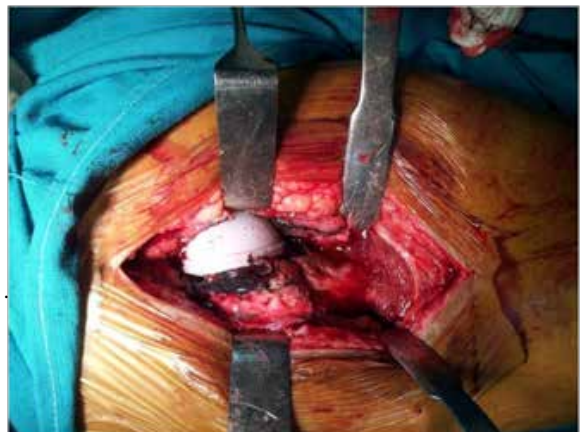
Popped up liner and blackening of tissues

A 45 year old male patient came to our department with pain in bilateral hip since one year . on examination the range of movement in bilateral hip was reduced . all routine investigations done and patient diagnosed as avascular necrosis of bilateral hip on the basis of MRI . total hip replacement done bilaterally and patient discharged . after six month patient came with pain and crackling sound every time he walked in right hip The x-rays of right hip showed malalignment of Liner . Patient was reoperated keeping all possible resources available . intraoperatively we found Popped up liner and metal reaction causing blackening of the tissues . Liner removed head dislocated . proper debridment done and a new liner applied . postoperative x-rays were satisfactory .

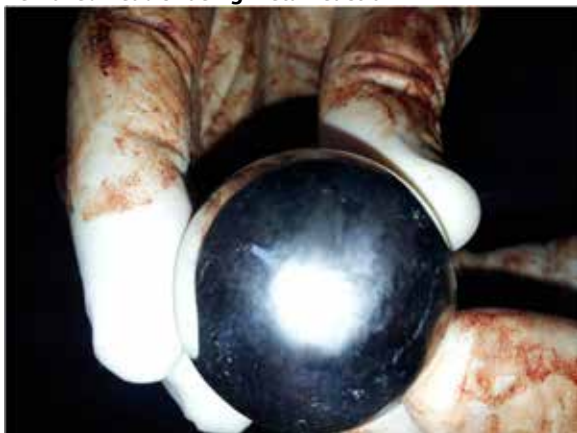
Removed head shoeing metal reaction
