Management of Separated Instruments in the Root Canal - Three Case Reports

Bypassing, separated instrument, small file, warm vertical compaction.

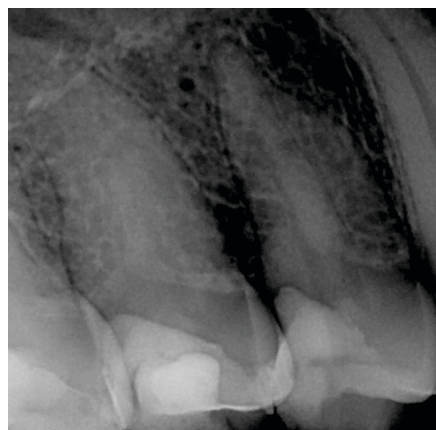
Figure 1: Pre-operative radiograph

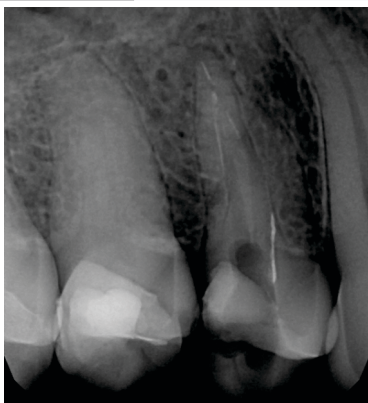
approaching the pulp chamber. From clinical and radiographic findings, a diagnosis of symptomatic irreversible pulpitis was made. Treatment options were discussed with the patient and endodontic therapy was the treatment of choice. The tooth was anaesthetised with 1.8 ml 2% lignocaine containing 1:200,000 adrenaline followed by rubber dam isolation. An endodontic access cavity was established. While cleaning and shaping the canals, a 15 size K file was separated in the palatal canal of maxillary first premolar at apex.

Figure 2: Radiograph of 14 showing fractured file in palatal canal.

Since the fractured segment could not be visualised and was below the root curvature, bypassing was preferred over retrieval. The access cavity was filled with chelating agent - 17% EDTA (Avuprep) and a no.6 K file was introduced into the canal for searching a way to bypass the instrument. After a few tries, it was able to get the 6K file past the instrument. Working length was confirmed radiographically. During the shaping of canals, copious irrigation with 5% sodium hypochlorite and saline was performed. Patency was kept with an 8 size K file between every instrument. Shaping of buccal and palatal canals were done up to 6% 25 hero shaper.

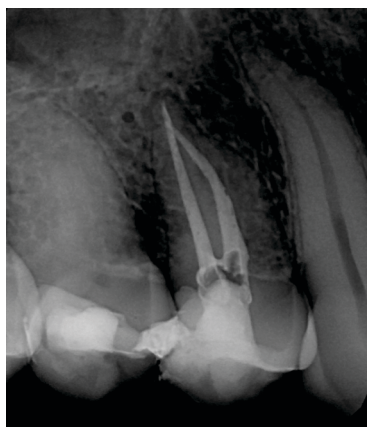
Figure 3: Post obturation radiograph after bypassing the fractured file

After shaping and cleaning, calcium hydroxide (Avucal) was placed in canals and the cavity was sealed with cotton pellet and a temporary restoration was given. After 2 weeks, patient reported for the second appointment. The tooth was again isolated and temporary restoration was removed. Calcium hydroxide was removed using sterile saline solution. Canals were dried using paper points. Obturation was done using warm vertical compaction technique. Post obturation radiograph was taken. Recall visits were uneventful and the patient is still under review.

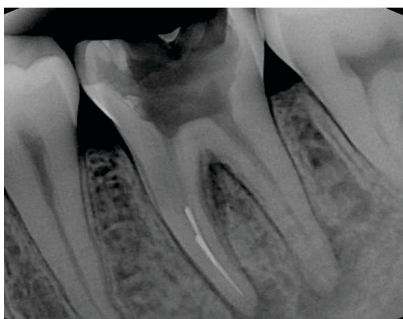
A 25-year old male patient was referred to my clinic for the treatment of left mandibular first molar. The referring dentist had already performed preliminary root canal treatment. Before starting the treatment, a new diagnostic radiograph was taken. It showed fractured instruments in the mesio-buccal and mesio-lingual canal. In the radiograph mesial root looks very thin and narrow, instrument removal would lead to unnecessary removal of dentin and thereby weakening the root structure. The decision was made to try to bypass the instrument rather than try to retrieve it. The tooth was anesthetised with 1.8 ml 2% lignocaine containing 1:200,000 adrenaline followed by rubber dam isolation. Similar procedure was followed as in case one to bypass the fractured instrument in mesio-buccal and mesio-lingual canal. Shaping of mesio-buccal and mesio-lingual canals were done upto 4%25 and distal canal upto 4% 35 Revo S rotary files (Micro Mega, France) followed by warm vertical compaction. Recall visits were uneventful and the patient is still under review.

Figure 4: Radiograph of 36 showing fractured instruments in mesio-buccal and mesio-lingual canal

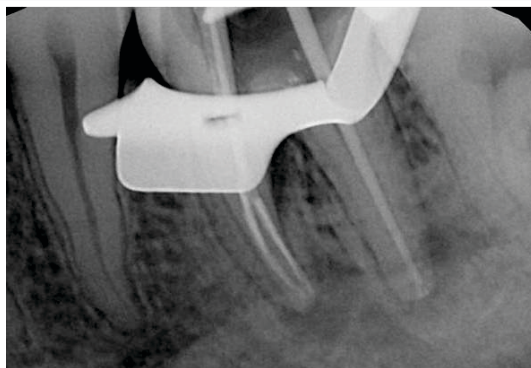
Figure 5: Master cone radiograph after bypassing the fractured instruments

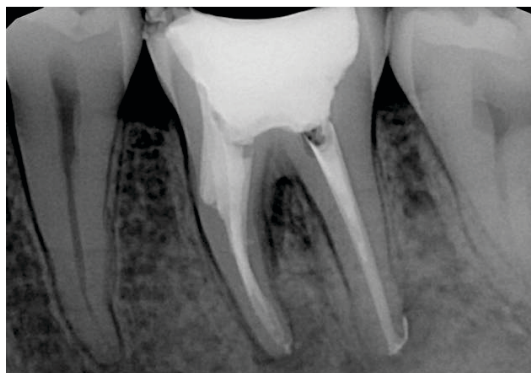
Figure 6: Post obturation radiograph after bypassing the fractured instruments

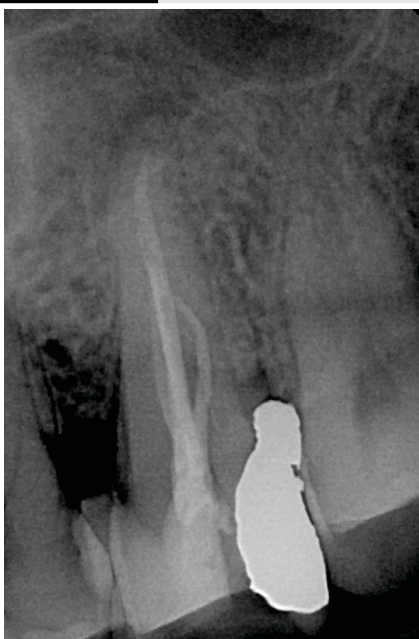
Figure 8: Post obturation radiograph after bypassing the fractured file.
