## FULL MOUTH REHABILITATION OF SEVERE FLUOROSIS CASE WITH WORN-OUT DENTITION WITH ALL- CERAMIC RESTORATION- A CASE REPORT

**ABSTRACT** Dental fluorosis is the hypomineralization of the enamel due to overexposure to excessive fluoride concentration during the time of tooth development. Severe discoloration and tooth wear are the main adverse effects of this condition. This case report describes 28 year old patient with generalized attrition of full complement of teeth with brownish discoloration, pitting and reduction in the vertical dimension due to severe dental Fluorosis. Complete rehabilitation of entire dentition was the proposed treatment and occlusal splint was used to increase the vertical dimension. Once the new vertical dimension was established provisional fixed restoration followed by permanent rehabilitation. The following case report proposes that a promising clinical outcome was obtained by re-establishment of the vertical dimension with improvisation in esthetics and function.

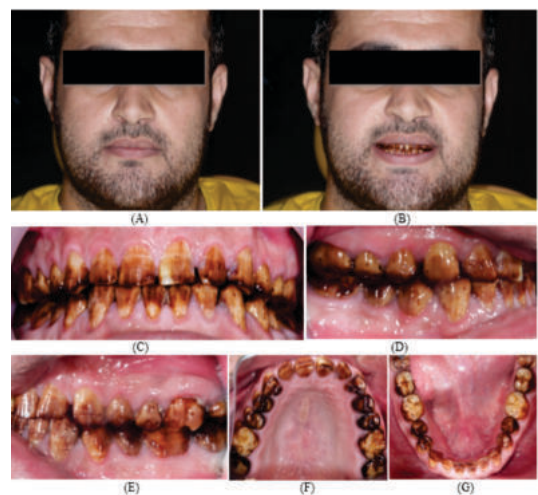
expressed dissatisfaction with the appearance of his dentition. His deciduous dentition was normal, but his permanent teeth had been stained since eruption, according to his dental history. Family history revealed presence of similar discoloured dentition among other family members. On extraoral examination, the patient's temporomandibular joints and masticatory muscles were found to be normal and had a low smile line. On intraoral examination, full complement of permanent teeth was present with group function occlusion and class 1 molar relation except the maxillary third molars. However, generalized brownish discoloration with pitting present on canine and posterior teeth was noticed. Generalized attrition had resulted in reduced clinical crown height and edge to edge occlusion. On soft tissue examination there was no gingival recession, periodontal pockets or bleeding on probing present [Figure 1].

**figure 1:** Preoperative Clinical Photographs: (A) Facial Photograph, (B) Smile, (C) Frontal View of Dentition, (D) Right Lateral View, (E) Left Lateral View, (F) Maxillary Occlusal View, (G) Mandibular Occlusal View OPG (Orthopantomogram) of the patient showed adequate alveolar bone support and absence of periapical pathology [Figure 2].

The condition was diagnosed as generalized attrition of full complement of teeth with brownish discoloration, pitting and reduction in vertical dimension due to severe dental fluorosis. The proposed treatment was to completely rehabilitate the entire dentition with All-Ceramic restoration.

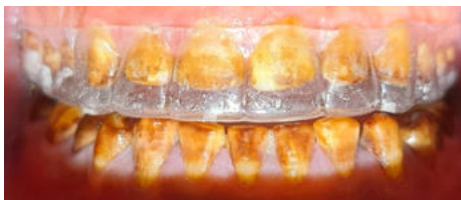
**Figure 3:** Diagnostic Occlusal Splint

The incisal rod was raised by 4mm to increase the OVD. A occlusal splint was fabricated at the new OVD to facilitate transition to the new OVD [Figure 3]. Patient was instructed to wear the occlusal splint for a period of 4 weeks and every week patient was recalled for evaluation. There was no evidence of tenderness or hyperactivity of masticatory muscle and abnormality of the temporomandibular joint.

The occlusal splint covers the entire occlusal surface of one arch and provides stable contact with opposing dentition at centric relation. It ensures posterior disocclusion on eccentric movements by maintaining anterior guidance. In addition to establishment of new VDO, occlusal splint acts as muscle deprogrammer and reposition the mandible to the most stable position that is centric relation.<sup>8</sup> The wearing period of diagnostic splint is 3 weeks to 5 months and of provisional fixed restoration is 2 to 6 months.<sup>9</sup> Since the patient had no temporomandibular joint problem or masticatory muscle tenderness during the recall visits, the occlusal splint was replaced with provisional restorations after 4 weeks. The parent's tolerance to the established VDO along with esthetics and phonetics was evaluated for 8 weeks before proceeding with the definitive treatment.

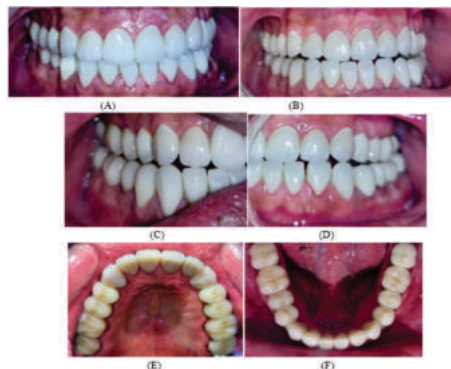
**Figure 6:** Postoperative Intraoral Photographs:( A) Frontal View of Dentition, (B) Protrusive Movement, (C) Right Lateral Excursive movement, (D) Left Lateral Excursive movement, (E) Maxillary Occlusal View, (F) Mandibular Occlusal View.

Intaglio surface of Zirconia Crowns were air- particle abraded using silica coated alumina particles of 60µm size at below 2 bar pressure. Tooth surface was pre- acid etched using 37% phosphoric acid ( 3M ESPE Scotchbond echant) for 15s and rinsed with water using 3 way dental syringe for 15s .On the sandblasted surface of the crown, a coat of Single Bond Universal TM (3 M ESPE) was applied and left for 15–20 seconds. To eliminate excess, the surface was air-dried and was light-cured for 10 sec. Same adhesive was rubbed on the air-dried tooth surface for 20 s which was blow dried and light cured for 10 s. The dual cure resin cement was then applied into the pretreated crown and placed over the prepared tooth, Tack cured for 2 s for easy removal of excess cement. This was followed by light curing for 20 s. [Figure 6]

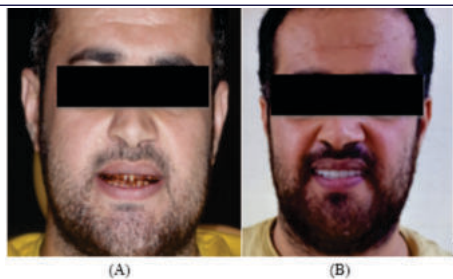
**Figure 8:** (A) Pre Op, (B) Post Op
