A Study On Temporal Change In Bank Line Of River Khowai At Alepsha, Khowai District, Tripura

KEYWORDS : Temporal change, channel shifting, bank material, Khowai River.

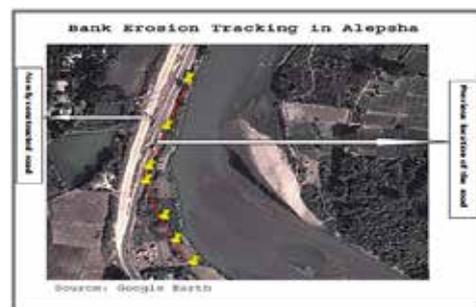
Fig. 2: Highly vulnerable left bank of the River Khowai at Alepsha tracked by GPS along the State Highway.

Here the Highway has been captured by the river and the tracking points are on the existing road. Another road has been constructed by the government on the land of the villagers. Temporary protective measures adopted by means of local wood/bamboo permeable spurs have failed to protect river bank from erosion. As a result, the river course is gradually shifting towards the cultivated land, homesteads, various plantations etc. From 1966 to 1988 (22 years) the rate of shifting was 10m/year towards west. Again from 1988 to 2010 (22 years) the rate of shifting was 8.7 and 1.37m/year towards west and east respectively within Alepsha (Fig. 3).

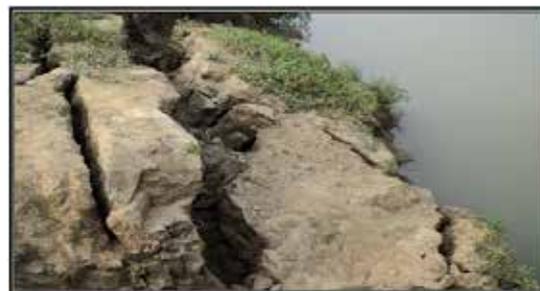
Plate 1: After recession of flood water the bank is ready to

collapse at Alepsha.

When a river bank consists of high amount of sand but lesser amount of clay that means the bank material is less cohesive and more susceptible to erosion. During heavy discharge, water penetrates through the interstitial spaces of sandy beds. After recession of high water level, lateral flow of sand and silt into the channel takes place which leads to disequilibrium condition in the bank itself and the bank failure takes place (Plate 1).

Moreover, the site lacks vegetation root depth and density which is another cause of bank failure. Bank sediment with a root volume of 16-18% and a 5 cm root mat can afford 20000 times more protection from erosion than comparable sediment without vegetation (Smith, 1976). Steep bank angle also indicates the high risk of bank erosion hazard in this portion. Presence of all these factors at Alepsha indicates its vulnerability to bank erosion.
