## BONE REGENERATION FOR RE-INTEGRATION OF FAILING IMPLANT: A DENTIST NIGHTMARE.

### Dental Science

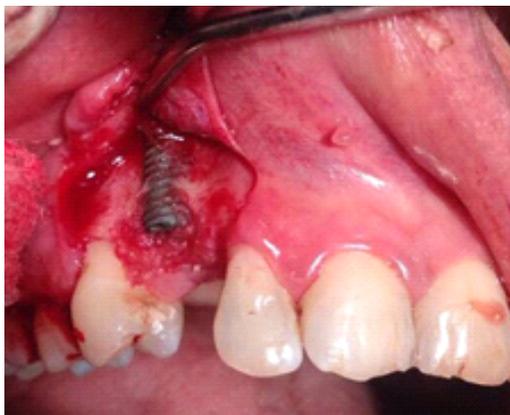
**Fig 1 : Implant exposure**

Under LA, Incision was given and periodontal flap was reflected to expose the implant. On exposure, buccal bone resorption was noted which was extended till the last thread of the implant (Figure 1) Scaling and Curettage was done with the help of plastic instruments around the implant area. After the complete removal of granulation tissue, surface decontamination was done using diode laser therapy around the implants at 940nm. PerioGlas<sup>®</sup> (NovaBone Products, LLC, Alachua, Florida, USA) was placed at the defect (Figure 2), which was further covered with a collagen GTR membrane (Healiguide<sup>®</sup>, Advanced Biotech Products Pvt. Ltd., Chennai, India) so that surrounding 2-3mm of alveolar bone is covered and the graft is stabilized (Figure 3). Primary wound closure was obtained, using non-resorbable silk sutures (Mersilk<sup>®</sup>, Ethicon, Johnson and Johnson, India) and the area was covered with periodontal dressing (Coe-pak, G. C. India) for 14days. The post operative instructions were given and medication was continued. Patient was advised to rinse with 0.2% chlorhexidine twice daily for a week and was instructed to avoid brushing on the operated site. The dressing and sutures were removed after 14 days. Oral hygiene instructions were reinforced. Recall was done after 1 month following which patient was put on 6 months recall.

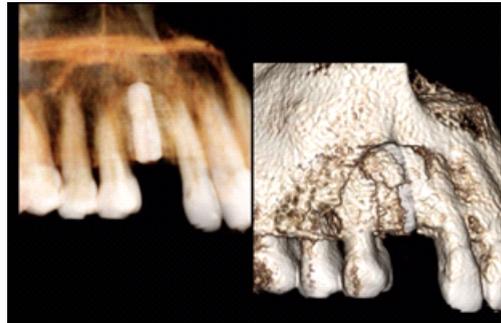
**Fig 4 : CBCT after 9 months**

At the end of 6 months follow up, tissue healing was satisfactory. After 9 months, CBCT was performed to have a check on the amount of buccal bone deposition. The amount of bone gain of 0.5mm was reported and the abutment was placed followed by placement of crown (Figure 4). After 12 months from baseline (implant placement), CBCT was repeated and there was a further gain of 0.75mm -1.0mm at the peri-implant area (Figure 5).
