## A RARE CASE REPORT OF METALLOSIS - LEFT HIP IMPLANT POST SURGERY

## Pathology

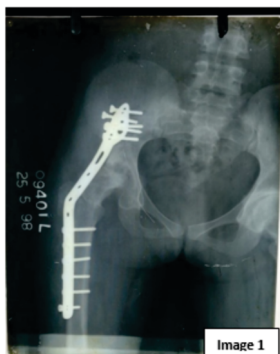
**Image 1: An old X-ray of the hip joint showed an operated left hip with a metallic plate replacing the left acetabulum, head and neck of femur.**

A 42 year old female presented with inability to walk along with severe persistent pain around the left hip region since 20 days. The patient did not have any comorbidity. On examination, the left lower limb was externally rotated and active Straight Leg Raise test (SLR) was not possible. There was shortening of left lower limb by 4 cm. On eliciting history, patient was diagnosed as a case of Perthes disease at B.Y.L. Nair Hospital in the year 1998. She was operated for left hip arthrodesis using a femoropelvic spoon plate made up of stainless steel as evident on the X ray (Image 1)

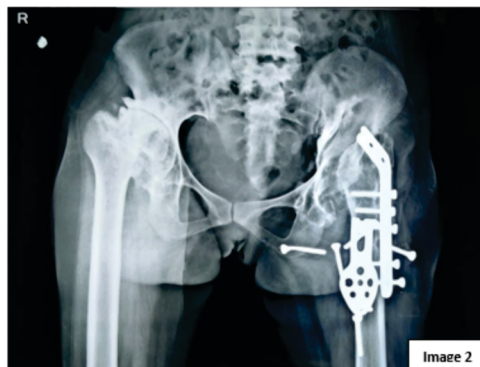
**Image 2: The X-ray of the hip joint showed an operated left hip with broken metal implant and arthritic changes of the right hip joint.**

Radiological findings suggested an operated left hip joint with a broken implant and resorption of the femoral head. The right hip joint showed arthritic changes. The right head of femur is sclerosed with irregular margin. The neck of the femur is collapsed and the joint space is reduced. (Image 2)

Since 20 years, the patient was walking with a limp associated with minimal pain. She developed severe pain 20 days ago with trivial trauma possibly causing implant breakage and was not able to walk since then. An implant removal surgery with a complex total hip replacement surgery was planned. During the surgery, the broken implant was removed and a layer of glistening black soft tissue was found beneath the implant adhered to the bone. The tissue was sent for histopathological examination.

Due to flattened acetabulum and deficient bone, total hip replacement was deferred and a Girdle Stone Arthroplasty was performed. After surgery the patient made a good recovery and was stable without any symptoms of pain or swelling.

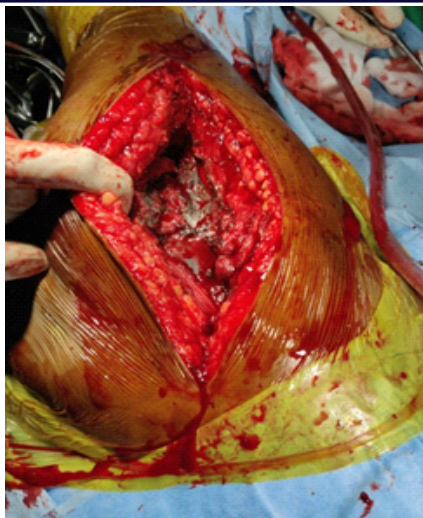
**Image 3** depicts intraoperative pictures of the procedure showing debridement of dark grey tissue attached to the bone surface beneath with irregular margins showing extensive metallosis and metal impregnation in the surrounding tissue.

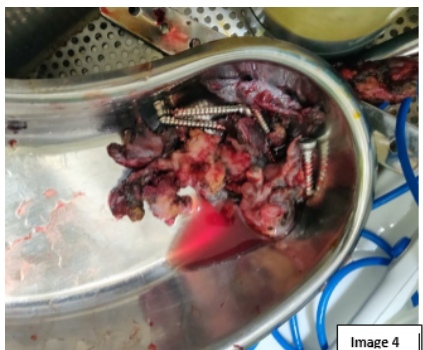
**Image 4** depicts the macroscopic appearance of the tissue excised showing greyish black metallic material.

**Gross examination:** Received single, greyish-black, soft to firm tissue piece measuring 1.2 x 1.2 cm.
