FRACTURED GUIDEWIRE OF HAEMODIALYSIS CATHETER.

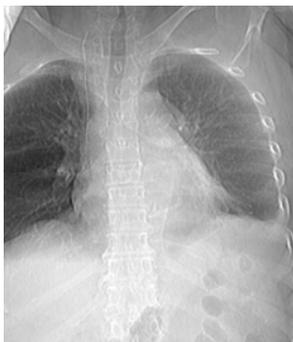
Image 1- Chest X-ray showing fractured guidewire.

As a routine protocol, ultrasound screening was done for right internal jugular vein to rule out thrombus and anatomical variations. An Experienced Interventionist punctured right internal jugular vein under ultrasound guidance. After a successful venepuncture confirmed with aspiration, guidewire was inserted. Serial dilatation of the skin and subcutaneous tract was done. The skin was pierced with some difficulty. The dilatation was difficult owing to presence of subcutaneous fat. Triple lumen HD catheter was inserted with Seldinger technique over the guidewire. After insertion, when guidewire was taken out, resistance was felt. Operator noticed a jerk and instead of complete guidewire, a part of core and avulsed coils came out from within the catheter. It was recognised that the guidewire was broken. As a possible attempt to remove the remaining part of fractured guidewire, the HD catheter was also removed. After this attempt, X-ray chest was taken which revealed the broken residual

fragment in internal jugular vein (Image 1). Patient was hemodynamically stable. A non-contrast CT thorax was done to identify exact location of fractured guidewire, probable migration and injury to adjacent structures (image 2). Relatives were explained the scenario and emergency retrieval procedure was planned in Cardiac Catheterization Lab to remove the guidewire.
