## MANAGEMENT OF ELISS CLASS IV FRACTURE USING FIBER POST : A CASE REPORT

### Endodontics

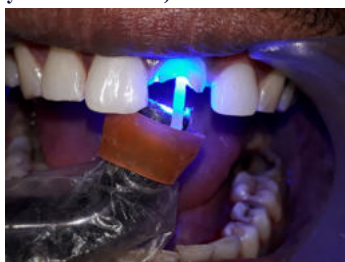
**Figure-5 (Rely X U 100 Cement)**

Post cementation was done with Rely X Unicem Self Adhesive Universal Resin Cement (3M ESPE, Germany) (Fig.5&6) followed by core build up with resin (Tetric N Ceram, Ivoclar Vivadent, Schaan Liechtenstein).(Fig.7)
