ISOLATED TRAUMATIC BILATERAL PATELLA FRACTURE

Orthopaedics

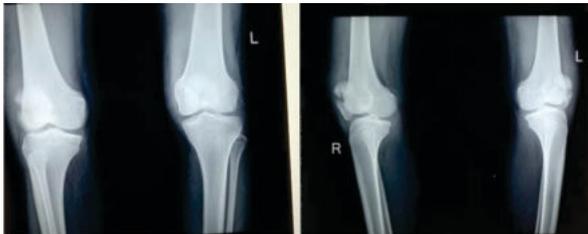
Figure 1

A 20-years female came to our emergency at JLNMC, BHAGALPUR with history of road traffic accident, as she was hit by a four-wheeler. There was no history suggestive of chest, abdominal, facial, head or spinal injury, ear or nose bleeding. The vital signs were stable and the main complaints were pain, gross swelling of bilateral knee joint. Clinical examination on admission revealed a healthy female, who was fully conscious and oriented with a GCS score of 15/15. Clinical examination of spine and pelvis showed normal results. She had no medical co-morbidities. On bilateral knee examination, tenderness was present along with crepitus and painful range of movement. There was a 1.5 cm × 2 cm superficial abrasion over the anterior aspect of the right knee. Skin over left knee was intact. The patient was unable to do active Straight Leg Raising [SLR] on both sides. Distal circulation and neurology in both lower limbs were normal. Plain X-rays, including anteroposterior and lateral views of both knee joints were performed. Routine trauma series X-rays, including chest X-ray, X-ray pelvis with both hip joints- anteroposterior view, and X-rays of cervical and lumbar spine were normal. The patient presented with simultaneous and isolated bilateral patella fracture. On the right side, there was comminuted fracture of patella and on the left side there was transverse fracture of the patella (figure 1). Cylindrical slab was applied over both lower limbs.

Our patient had peculiar fracture pattern; with comminuted fracture in right side and transverse fracture at left side.

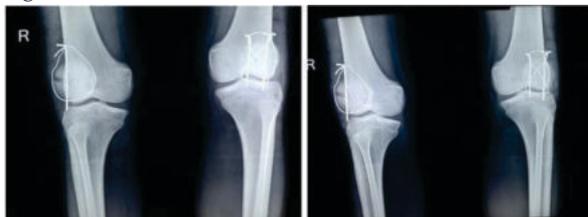
Figure 2

On post-operative day 2, drain was removed. X-ray bilateral knee was advised (figure 2). Patient was advised for quadriceps and hamstring exercises.

were passed from distal fragment to proximal fragment through the fracture. Using 18-gauge SS wire, tension band wiring was done and compression at fracture site was achieved. Reduction was confirmed using C-arm machine in both anteroposterior and lateral view. K-wires were cut bent and deeply buried inside the soft tissue. Wound was washed thoroughly with normal saline. Medial and lateral retinaculum were repaired. Subcutaneous tissue and skin were closed in layers. Tourniquet was deflated, negative suction drain was also fixed.

On right side, through a straight midline incision, the patella was exposed. The patella had severe comminution and reduction using tension band wiring was impossible. As the comminution was not amenable to be fixed, so transosseous vicryl through the larger fragment was passed and encircled using Kirschner wire and 18G SS wire was done. The small comminuted fragment was resected. After the surgery, both knees were kept in full extension with a hinged knee immobilizer.

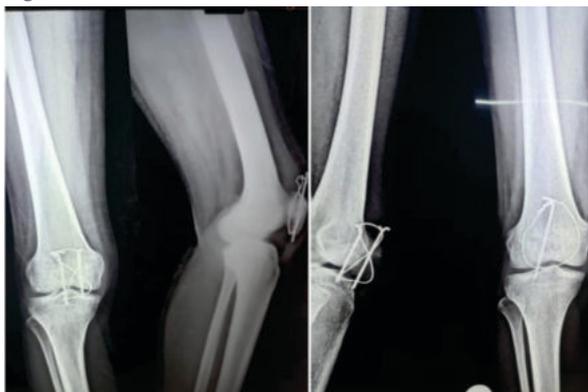
Figure 3

Gradual knee exercises were initiated after one week. Stitches were removed after 14 days and gradual knee movement was initiated. Gradual weight bearing was started at 4 weeks. At 6 weeks of post-operative follow-up, patient had 5-to-90-degree passive knee ROM. At 3 months follow up, patient had knee passive ROM of 0 to 90 degrees. Her follow up x-ray as seen in (figure 3).
