**A CASE REPORT OF NEGLECTED ACETABULUM FRACTURE WITH CENTRAL DISLOCATION OF FEMORAL HEAD AND SECONDARY ARTHRITIS OF HIP TREATED WITH PRIMARY TOTAL HIP REPLACEMENT AND ACETABULUM RECONSTRUCTION WITH CAGE FIXATION & G-BONE GRAFTING**

**Orthopaedics**

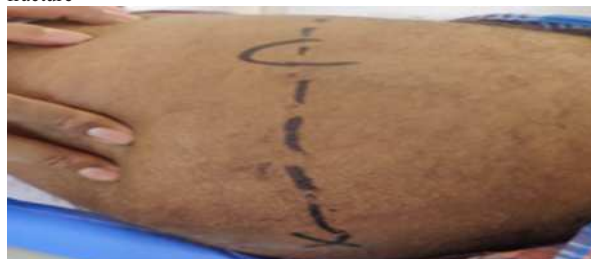
Nelaton's Line [figure 1]: The greater trochanter on the right side appeared to have migrated to the superior aspect; this phenomenon is a sign of hip dislocation or significant damage to the structures due to fracture

**Figure 1 Superior Migration of Greater Trochanter (Nelaton's Line)**

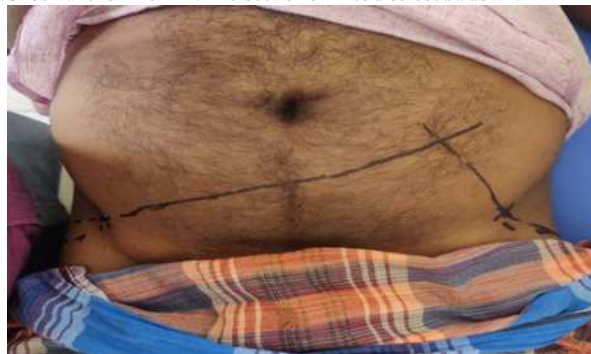
Shoemaker's Line<sup>[figure2]</sup>: Intersection of lines disclosed a down.

**Figure 2 Intersection of Shoemaker's line on left side**

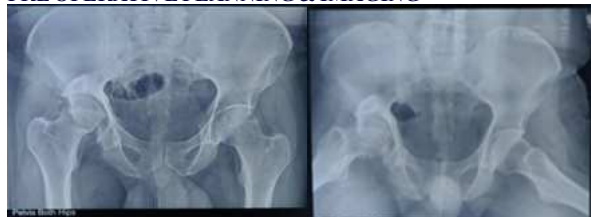
**Figure 3** X ray pelvis with both hips ap view

X-ray images showed the disrupted anatomical lines which include the ilioischial, iliopectineal, and Shenton lines, which reflect a high acetabular break. The femoral head seems high-riding, and there is profound subchondral sclerosis which indicates chronicity. Other features given on X-rays are:

Ilioischial Line: Disrupted, suggestive of a posterior column fracture.

Iliopectineal Line: Disrupted, suggestive of an anterior column fracture.

Shenton's Line: Disrupted—an evidence of the further dislocated head of femur.

Superior Acetabulum: Cortical thickening and sclerosis present and the site depicts a healed injury; the fracture is old.

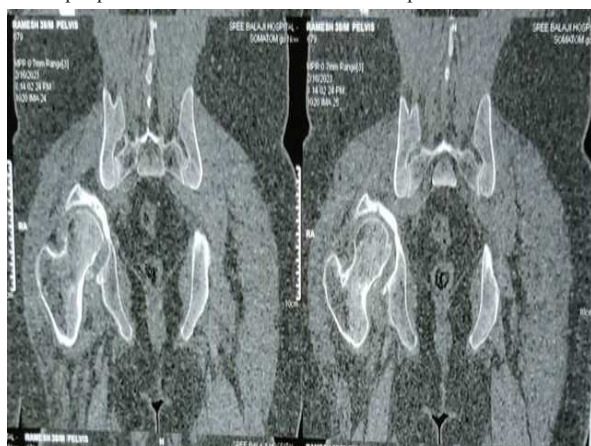
**Figure 4** X ray pelvis with both hips lateral view

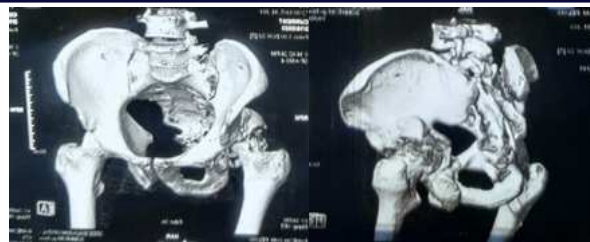
**Figure 5 (a)** CT scan

**Figure 5 (b)** CT Scan

**Figure 5(c)** CT Scan

The femoral head is significantly malaligned with postero-inferior displacement, suggestive that much of the femoral head is not properly seated in the acetabulum.

Acetabulum: Noticeable sclerosis and cortical thickening are seen, which may connote chronic changes and remodeling because the injury is very old.

Posterior Acetabular Wall: This is displaced superiorly and posteriorly,

confirming the involvement of the posterior column.

**Crest of the Ilium:** The cortex is thickened and there is sclerotic change, pointing to a process of stress response or chronic load-bearing changes.

**Right Hip Joint Effusion:** Mild effusion again hints at some inflammation inside the joint.

**Intra-articular Loose Bodies:** A few hyperdense bony fragments, suggestive of degenerative changes of the cartilage and bone in the intra-articular space.
