## KINKING & UNCOILING OF GUIDEWIRE-A RARE & PREVENTABLE COMPLICATION- A CASE REPORT & SYSTEMIC ANALYSIS ON MEASURES TO PREVENT IT.

### Anaesthesiology

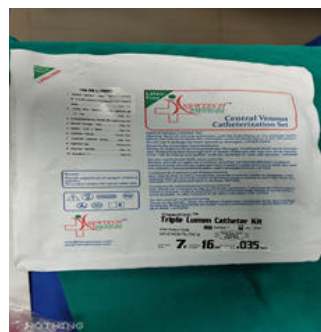
**Figure 1** Showing central venous catheter set

Initially 2% Lignocaine was injected at the entry site in the right infraclavicular area. Then, the right subclavian vein was identified using an infraclavicular approach. A Seldinger-type central venous catheter set was used (Triple-Lumen Clear CVC Catheter Kit 7 Fr, 16 cm Catheter length with 0.035-inch guidewire diameter by New Tech Medical Devices). After initial venous backflow the guidewire was passed smoothly and the introducer needle removed. Then dilator was used, and central venous catheter was threaded over the guidewire with the distal port open. The guidewire was found coming out through the distal port and after holding the guidewire the catheter was threaded. Initially there was little resistance in removing the guidewire and moderate force was used which further caused more resistance and we found that the guidewire had started uncoiling which caused further difficulty in removal. Later with continuous force application we could luckily remove the guidewire en bloc. All three ports were checked and found patent and an immediate chest X-ray revealed proper positioning without any complications. We found on examination of the guidewire that the J Tip had kinked and there was uncoiling with stretching of the guidewire as shown in Figure 2.

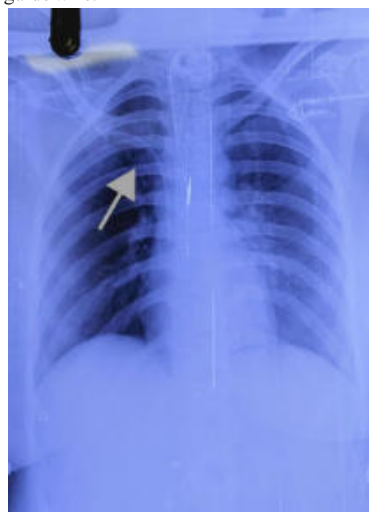
A postoperative chest x-ray taken in the post anesthesia care unit, and a follow-up film six hours later revealed no signs of hemothorax, or pneumothorax as shown in Figure 3. We experienced a case of left subclavian venous catheterization complicated by intravascular

**Figure 3** shows post procedure Chest X ray with white arrow pointing to CVC in place.
