Planning of Facilities for Pedestrian Movement in Urban Area: A Case Study of Vadaj Circle, Ahmedabad

* M.E. SEM IV Transportation Engineering, L.D. College of Engineering, Ahmedabad

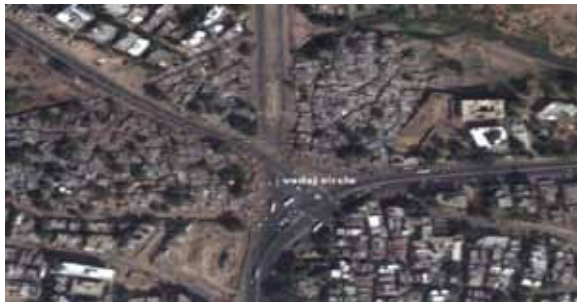
Figure: 2 selected circle

The shown in fig.2 at selected area. This circle is connected from Subhash Bridge, Usmanpura, Bhimjipura and Ranip.

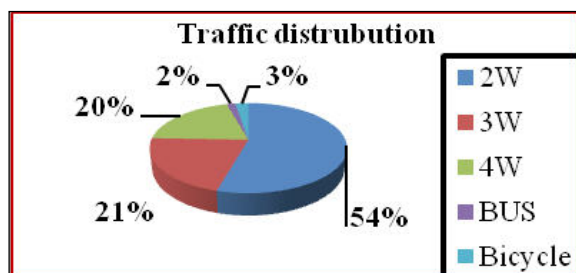
Figure: 3 Traffic composition of at selected circle

This survey is carried out during morning peak hours at time 8:30 to 11:30 am and also evening peak hours at time 4:30 to 7:30 pm the date of 6/02/2012 by employing enumerators at each of the above location, covering both directions i.e. inflow and Outflow. Manual count with 15-minute interval is used to obtain the traffic volume data. The data collection table and analysis of this data figure showed as below.

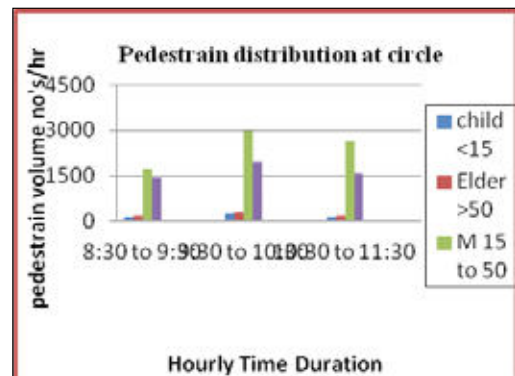
Figure: 5 Pedestrian volume distributions at circle in morning peak hours

Pedestrian volume counts were taken at all legs in this circle. this survey is carried out morning peak hours at time 8:30 to 11:30 am and also evening peak hours at time 4:30 to 7:30 pm the date of 6/02/2012 by employing enumerators at each leg. To conduct pedestrian surveys, at all leg A, B,C,D, are the points in this circle where pedestrian disperse . At each of these legs two enumerators were employed, one of them has counted number of inflow and other counts outflow pedestrian .This counting process is carried out for all legs.

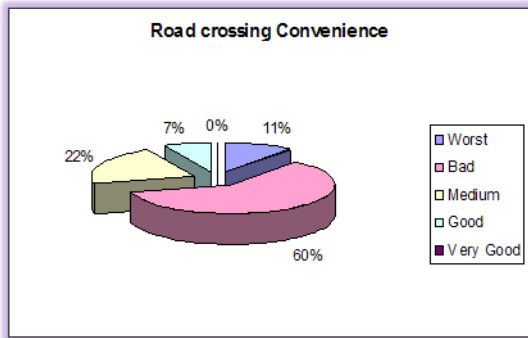
Road crossing convenience is bad as it has been responded by the people. People have to walk long distances to cross the roads. This is because of the high traffic and no provision of road crossing facilities.
