ORIGINAL RESEARCH PAPER

Dental Science

A TEMPLATE AIDED ESTHETIC REHABILITATION OF FRACTURED ANTERIOR TEETH - A CASE REPORT

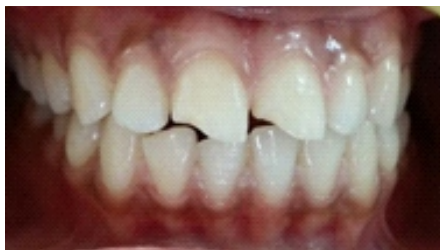
A 20-year-old young female under graduate dental student reported to the Department of Conservative Dentistry & Endodontics, with the chief complaint of fractured upper front teeth. The patient gave a history of trauma 10 years back due to falling from a bicycle. Clinical examination revealed Ellis class II (uncomplicated) fracture irt #8 and #9 [Fig-1]. The tooth was asymptomatic and responded to EPT.

Fig 1: Preoperative photograph showing Elli's Class II fracture in relation to #8 and #9.

Esthetic restoration of the fractured anterior teeth was planned using template aided direct composite restoration technique.
