To Reduce the Rejection of Halogen Lamp at Sealing Stage during Manufacturing

This report gives the quality improvements that are needed to reduce the defects at the "Sealing stage" of manufacturing Halogen Lamps at M/S Autolite (India) Ltd, Sitapura, Jaipur.

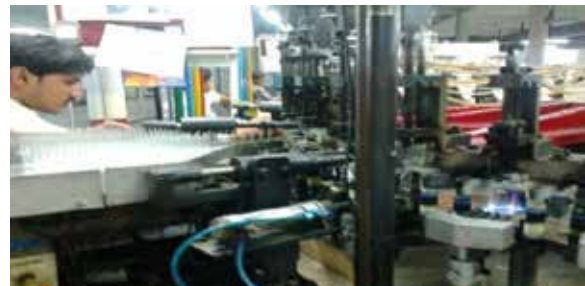
Fig 1;Bulb Shell Tube Feeding

In Autolite (India) Limited, Jaipur 36 head Turret machine is used for sealing the mount with bulb glass tube. In this process tabulated bulbs are loaded into the upper Fixture and mounts are loaded into the lower Fixture of the turret head at respective Insertion station of machine feeding system. The Bulb shell is dropped down over the mount by Bell crank lever arrangement operated with the help of Special Cam mecha-

nism and mount is hold by mount holding jaw for correct positioning before the first burner for heating.

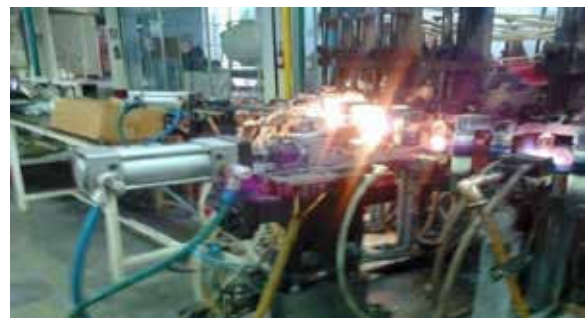
Fig.2: Stainless Steel Pressure pads

The heating of Bulb shell is done by Burners in increasing order of temperature from room temperature to 1800 OC at Burner station No.1 to Burner Station No.11 for sealing. From burner station no.2 to Burner Station no.11 air and LPG are used for producing the flame for heating the bulb, Between Burner station No.3 and Burner station No.4 Stainless steel press pads (hammer) are used to change the circular shape of bulb into rectangular shape and producing first pinch, then from Burner station No.4 to Burner station No.11 temperature is continuously increased by burners. Between burner station No.11 and burner station No.12 when final temperature gains is 1800 OC final leak proof seal develops between glass bulb shell and mount be produce by pressing them with second Stainless steel press pads.

A machine called a press seal is used to hermetically seal the mount inside the bulb. Stainless steel press pads or hammers operating at pressures of 1.406 Kg/cm² to 4.225 Kg/cm²(20-60 psi), press the borosilicate glass to the molybdenum foils forming the hermetic seal. At present in the sealing machine Rectangular shaped stainless steel press pads of (17 mm x 15 mm) are used for producing a bulb seal of volume (15 mm x11mm x 4 mm) which leaves some clearance in between the mount and glass bulb shell .If there is an variable pressure of steel press pads, defects may produce.

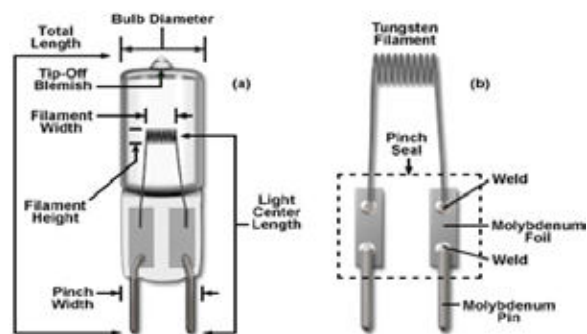
Fig.4: Pinch width

The width of this zone is about 6 to 8 mm. It is heated not to melting temperature however, but only to a working temperature of about 1100 oC that is until the glass will have the viscosity of about 10 4 poise.It is plastic however and is then pinch-sealed to the wire. This is the first pinching step.

The pinch will surround mechanically the lead wires without however at this stage wetting the lead wires that is being fused. When the pinch tool or pinch hammer has been withdrawn from the pinch zone where the pinch was preliminarily formed only localized heating is carried out. In a preferred form, the heating is so localized that only those portions of the glass which are immediately adjacent the wires are heated to fusion temperature, that is to liquefaction. When those por-

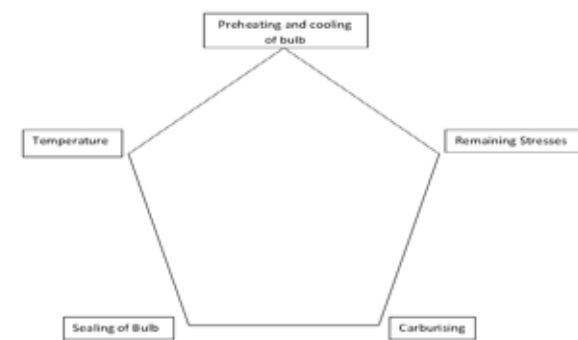
Fig.6: Parameters

1. Temperature
2. Preheating & Cooling Effect
3. Remaining Stresses
4. Sealing of bulb shell
5. Carburising of bulb shell

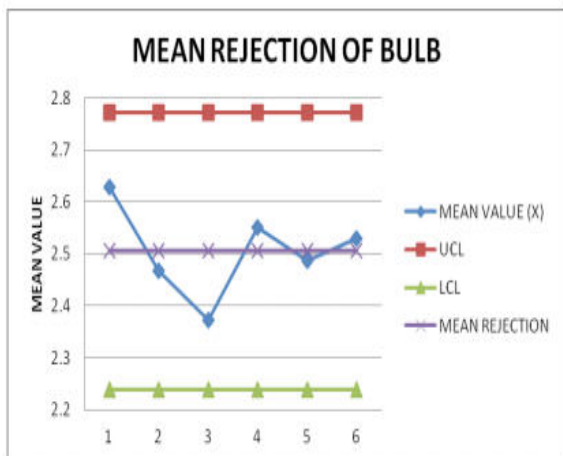
Table 3:X-Bar chart with their limits:

S.No.	SAMPLE SIZE (5)	MEAN VALUE (\bar{x})	UCL	LCL	$\bar{X} = \frac{\bar{x}_1 + \bar{x}_2 + \bar{x}_3 + \bar{x}_4 + \bar{x}_5 + \bar{x}_6}{5}$ $= 2.506$
1	\bar{x}_1	2.628	2.772	2.239	
2	\bar{x}_2	2.468	2.772	2.239	
3	\bar{x}_3	2.372	2.772	2.239	
4	\bar{x}_4	2.552	2.772	2.239	
5	\bar{x}_5	2.488	2.772	2.239	
6	\bar{x}_6	2.53	2.772	2.239

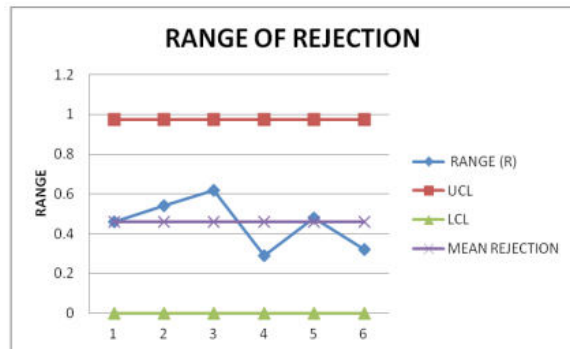
Graph 4: R-Bar chart with their limits:

SAMPLE No.	RANGE (R)	UCL	LCL	$\bar{R} = \frac{R_1 + R_2 + R_3 + R_4 + R_5 + R_6}{6}$ $= 0.461$
1	0.461	0.975	0.0	
2	0.54	0.975	0.0	
3	0.62	0.975	0.0	
4	0.29	0.975	0.0	
5	0.48	0.975	0.0	
6	0.32	0.975	0.0

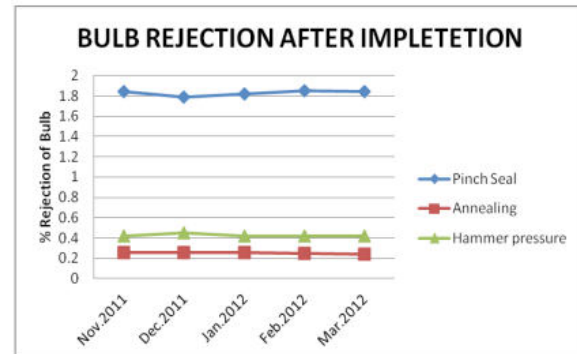
Graph 5: Rejection data from Nov.2011 to March2012 after implementation the remedial measures:

Month	Pinch Seal	Annealing	Hammer pressure	Total Rejection
Nov.11	1.84	0.257	0.418	2.51
Dec.11	1.79	0.259	0.451	2.50
Jan.12	1.82	0.257	0.423	2.50
Feb.12	1.851	0.246	0.418	2.51
Mar.12	1.841	0.238	0.42	2.50
Mean (%)	1.82%	0.251%	0.426%	2.50%
