Investigating the Condition of Gear Chips Being Dragged in A Single Stage Spur Gear Mesh

ABSTRACT

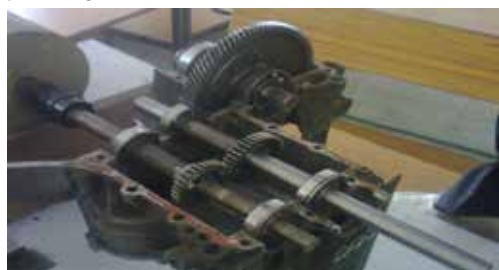
Figure 1- Experimental Setup

The gear chip pieces used in the experiment were liberated from a spare gear pair. The gear chips were created by scoring a mark on the gear tooth using rotating cutting wheel and then striking the score line with a cold chisel. These created chips were irregular in shape and sizes, these chips were then made in required shape and size by machining process. Grease is used when gear chips were engaged as lubricant. Gear chips were introduced in the gear mesh and rotated for a fixed duration by a input supply that is a DC motor at different speeds in the presence of grease. It was observed that if the chip would break into pieces or get deformed.

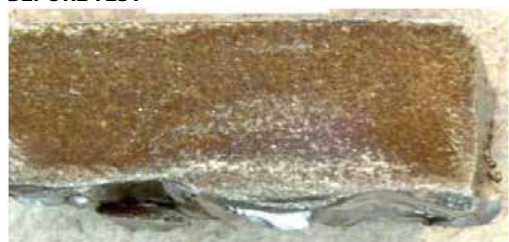
BEFORE TEST

Figure 2- Gear Chip(5 mm x 2 mm)

Figures below shows the images of the gear chips before and after engagement. The images show that there was only small deformation occurred on the chip surface but the chips does not go any severe breakage.

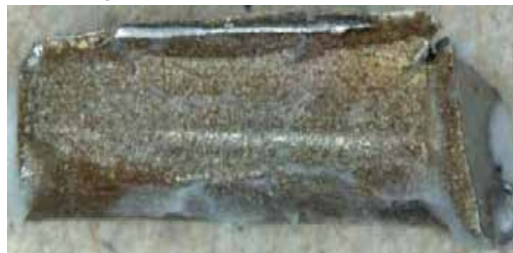
AFTER TEST

Figure 3- Gear Chip(5mm x 2mm)

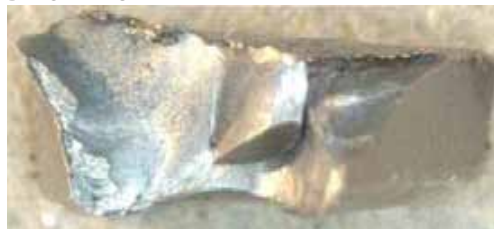
BEFORE TEST

Figure 4- Gear Chip(4 mm x 2 mm)

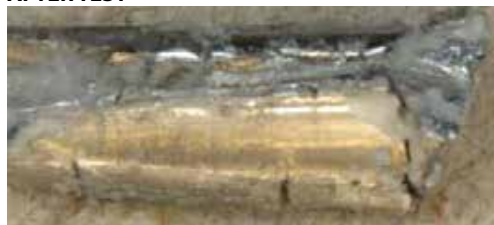
AFTER TEST

Figure 5- Gear Chip(4 mm x 2 mm)

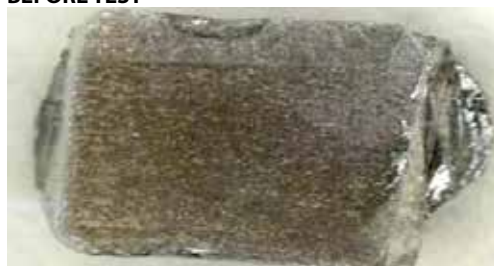
BEFORE TEST

Figure 6- Gear Chip(4 mm x 4 mm)

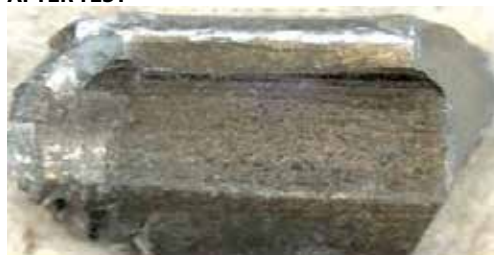
AFTER TEST

Figure 7- Gear Chip(4 mm x 4 mm)
