## STUDY OF DETECTION OF CRACKS IN SINGLE CRYSTALLINE SILICON WAFERS IN SOLAR PHOTOVOLTAIC CELL

**ABSTRACT** In this present investigation paper, acoustic measurements obtained by mechanically exciting vibratory modes in single crystalline silicon wafers with airline periphery cracks of different types and locations. The data presented shows a dependence of natural frequencies, peak amplitudes and damping levels of four audio vibration modes in the different frequency range up to 1000 Hz on crack types and crack locations. Data from defective single crystalline wafers exhibit lower natural frequencies, higher damping levels, and lower peak amplitudes. From the results suggest an impact test method may be very useful for solar cell crack detection and quality control in the photovoltaic industry.

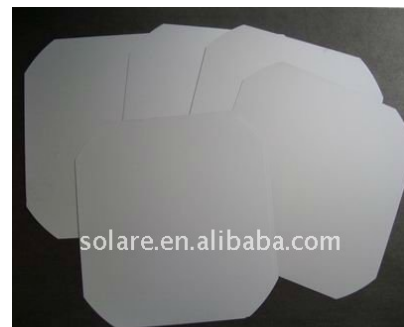
Figure2.1.1 Czochralski (Cz) silicon wafers

The test specimens are single crystalline (100) Czochralski (Cz) silicon wafers. They are pseudo square (see specimen corners in Figure 2.1) with dimensions 127 x 127 mm. The thickness of the wafers was found by weighing each wafers and knowing that the density of the wafer is 2.329 g/cm<sup>3</sup>. Some of the specimens are crack-free and some of the specimens have cracks introduced in different orientations. The crack-free wafers are scanned in a Scanning Acoustic Microscopy (SAM) before and after testing to ensure that the wafers had not been damaged during the impact testing. Cracks are introduced in the wafers using a diamond pin and pressing carefully on the edge of the wafers with a light force (equivalent to the force used in writing). By doing this, the human ear can hear the wafer crack. To quantify the cracks, the wafers are scanned in the SAM before and after the impact testing.
