## Occupational Therapy

# EFFICACY OF NOVEL THERMOPLASTIC HALO VEST AND THE CLINICAL OUTCOME FOLLOWING ITS USE FOR C4-C5 FRACTURE INJURY: A CASE REPORT.

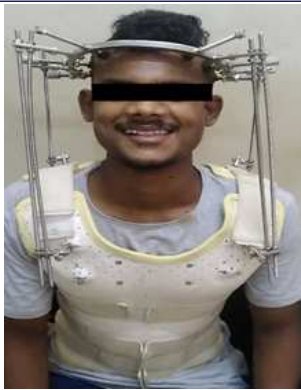
**Figure 1.** Novel Thermoplastic Halo vest

For moulding of the vest, two thermoplastic half sheets were used to ensure correct fitting of the vest on patient's body. As the cervical and upper thoracic spine are to be immobilized so the vest extended from the chest to the groin and had shoulder straps.

The vest was carefully moulded over the iliac crests and over all other bone prominences. The strapping was done with nawar straps and 4 screws (2 anterior and 2 posterior) were fixed on the vest to receive the attachments of extensions from the Halo ring.

The Orthopedic surgeons fixed the ring into the skull using 4 pins: 2 anterior pins (safe zone is a 1 cm region just above the lateral one third of the orbit (eyebrow) at or below the equator of the skull) and 2 posterior pins placed on opposite side of ring from anterior pins.

The extensions from the ring were attached to the screws fixed at the vest.<sup>6</sup> X rays were taken during the adjustments done to ensure proper fixation of the halo vest. The patient was explained about the follow-up care, proper pin and halo care to minimize the chances of infection (Figure 1).

Thus, this brace was made of thermoplastic material to ensure accurate fitting of the vest to the patient. It thus prevented the scapular pressure sores which are otherwise caused due to prolonged use of the vest. It also helped in prevention of Kyphosis.<sup>8</sup>

- Adjustments in attachments was easier before fixing the halo traction.
- Less expensive than other commercially available halo vest.
- Easily mouldable so no pressure sores
- Had pores so patient didn't complaint of any itchy skin or irritation

- Loosening of straps of lower part of vest helped the patient cleaning the lower trunk part
