## CHALLENGES OF PATIENTS WITH PACEMAKER FOR IPSILATERAL BREAST CONSERVING SURGERY FOR CARCINOMA BREAST – A CASE SERIES

### Anaesthesiology

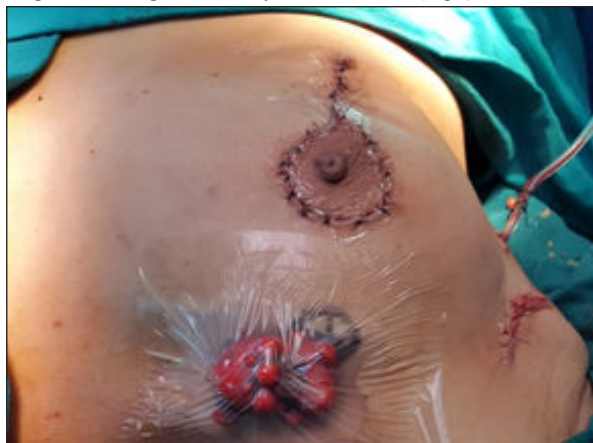
She had a history symptomatic bradycardia for which pacemaker was inserted in 2003. Anatomically, the pacemaker was in a subcutaneous tissue pocket in the upper pole of the right breast 5-6cm away from the primary tumour. No information was available regarding the type and the manufacture of the device, so reprogramming of the device was not possible. Chest xray showed a dual chamber device. Her transthoracic echocardiogram showed a normal ejection fraction and left ventricular size. All her laboratory investigations were normal. In the operation theatre other than the standard monitoring, left radial artery cannulation was done for invasive monitoring and a 5 f sheath was inserted in the internal jugular vein under ultrasound guidance for emergency temporary pacing. Emergency cart and the defibrillator was made available in the operation theatre. A magnet was placed over the pacemaker to produce an asynchronous mode (Fig 1)

**Fig 1** Magnet Secured With Sterile Tegaderm

sevoflurane was used for maintenance. During the surgery surgical scalpel and bipolar cautery was used. The cautery dispersal plate was placed on the leg. During the raising of the upper flap, the magnet got displaced resulting in bradycardia. However, by the immediate repositioning of the magnet the rhythm was restored. After the surgery she was shifted to the ICU after removing the magnet. After surgery she underwent partial breast irradiation with the lumpectomy cavity in the centre. Care was also taken to keep the leads and the wires kept out of the radiotherapy portal. A dosimeter was used to calculate the total exposed dosage of the radiation. No event of bradycardia/tachycardia/arrhythmia was recorded. The pacemaker engineer evaluated the pacemaker parameters every week. ECG was done before, during and after completion of course of radiotherapy.

In all three of our patient different challenges associated with pacemaker has been encountered. In the first case the pacemaker could not be programmed due to the unavailability of information regarding the pacemaker. We had placed magnet over the pacemaker to convert it to asynchronous mode. While magnet application to control CIED function is appropriate in some cases, in others, 'blind' magnet application alone as a management strategy might provide nothing more than a false sense of security because it might fail to address all necessary perioperative issues and accomplish the intended goals.<sup>1</sup> Unipolar cautery should not be used in these patients as EMI can cause a pacemaker to initiate a noise reversion mode or noise suppression protocol which triggers asynchronous pacing until the noise stops.<sup>1</sup> Bipolar cautery and Liga sure are preferred and short, irregular bursts with more 'cutting' than 'coagulating' current should be used.

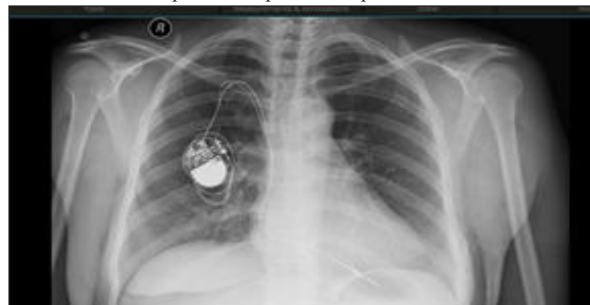
**Fig2** Pacemaker Leads In Chest X ray
