A RARE OCCURRENCE OF AN EMBEDDED TRANSPALATAL ARCH APPLIANCE- CASE REPORT

ABSTRACT

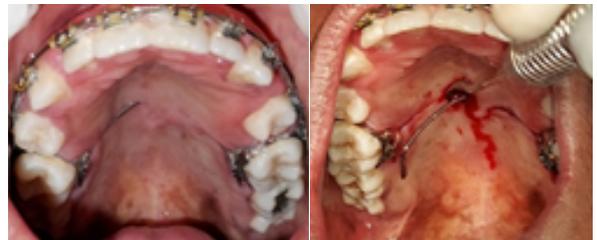
Fig 1

A 21 year old female patient reported to the Department of Periodontics at AJ Institute of Dental Sciences, Mangalore, with a complaint of an embedded orthodontic wire in the palate. She was undergoing fixed orthodontic treatment since 1.5 year and TPA appliance was placed for stabilization, 8 months back after which it was not removed. She noticed the tissue growth and gave a history of pain and irritation in the region. On clinical examination, an apparent embedment of the U-shaped loop and wire of the TPA appliance in the palatal mucosa was seen with inflammation in the surrounding area (Fig 1). After the intended stabilization function of TPA appliance was complete, it was indicated for removal with the consent of the Orthodontist. Patient was educated regarding the treatment procedure and a written consent was taken from the patient. Surgical protocols and safety guidelines were followed prior to the surgery. Adequate amount of local anaesthetic agent (lignocaine hydrochloride and Adrenaline 1:2,00,000) was infiltrated in the palate, until blanching was seen. Using a 15 No scalpel blade an incision was given on the palatal mucosa over the area of the transpalatal wire and the U-loop. The wire was visualized from the incised area. Near the U-loop, the mucosa was slightly elevated for complete access to the wire component (Fig 2). The appliance was deactivated with orthodontic pliers and the wire component was completely mobilized and removed. A simple interrupted suture was given using 3-0 silk suture at the elevated mucosal area near the U-loop region (Fig 3).

Post-operative instructions were given and analgesics were prescribed to the patient. She was recalled after a week for evaluation. Patient was satisfied with the treatment, the healing was uneventful. Complete healing was seen after a month (Fig 4).
