**ORIGINAL RESEARCH PAPER**

**MANAGEMENT OF MANDIBULAR MOLAR PERFORATION- USING MTA AS SEALING MATERIAL.**

**KEY WORDS:** Furcation Perforation, MTA, Microleakage

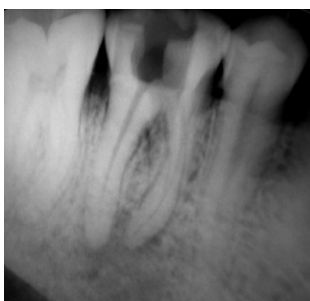
IOPA revealed furcation perforation in 46 (Fig 1). Non-Surgical repair of perforation with MTA after root canal therapy was planned and patient was appointed accordingly.

**Fig 1- Perforation seen in furcation of 46**
